**OKTAGON®**  
BONE LEVEL  
IMPLANTS

## Treatment with an OKTAGON® BONE LEVEL (BLT RC) Implant

### CASE OKTAGON

The current case describes a treatment of: a single anterior maxillary (incisor) post extractive implant management, with an OKTAGON® BONE LEVEL TAPERED RC (Regular Connect) and prosthetic rehabilitation.

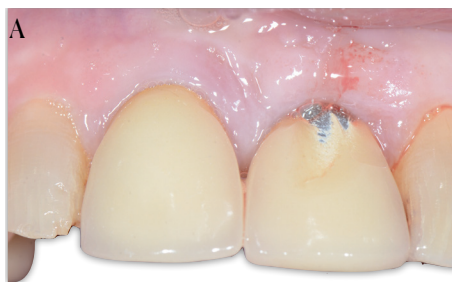
Fig. 1A

Intraoral photograph before operation

Radiographic examination before surgery

The patient came to our clinic for taking into account the replacement of a failure endo-prosthetic rehabilitation of upper central left incisor. (fig. 1 A-B)

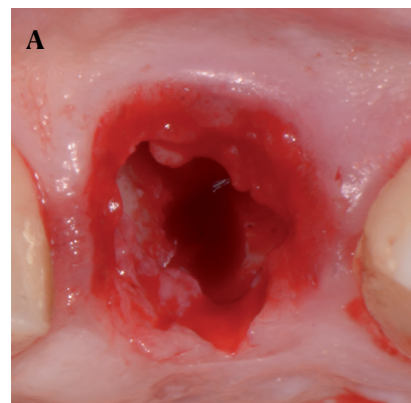
**Fig. 3 A**  
Detail of the osteotomic preparation

In this clinical case, a fractured upper central incisor was replaced by an immediate implant OKTAGON® (BLT Ø 4.1 L12 mm), and the perimetrical area was filled in with bioactive resorbable bone forming materials of plant origin (AlgOss) blended with platelet-rich fibrin (PRF) in the form of sticky bone. (fig. 3-4)

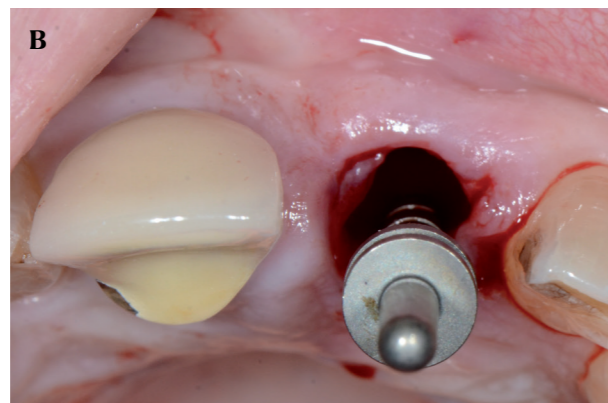
**Fig. 3 B**  
Emergence implant profile

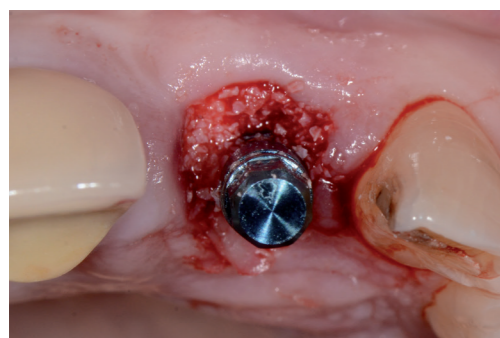
**Fig. 4**  
Socket gap with radioactive resorbable bone forming materials of plant origin (AlgOss) blended with platelet-rich fibrin (PRF) in the form of sticky bone

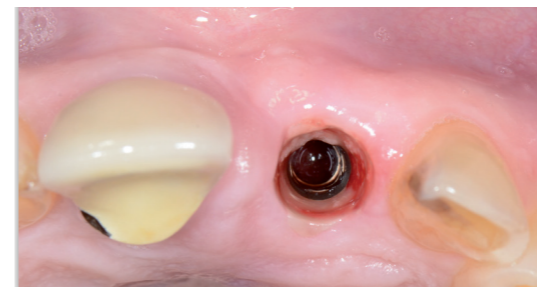
**Fig. 5 A**  
Clinical evaluation 48 h post op

**Fig. 5 B**  
Radiographic evaluation 48 h post op

The surgical key-factors of the treatment are: the palatal emergency of the implant (according with the prosthetic project) and, of course, the primary stability of the implant. (fig. 5A-B)

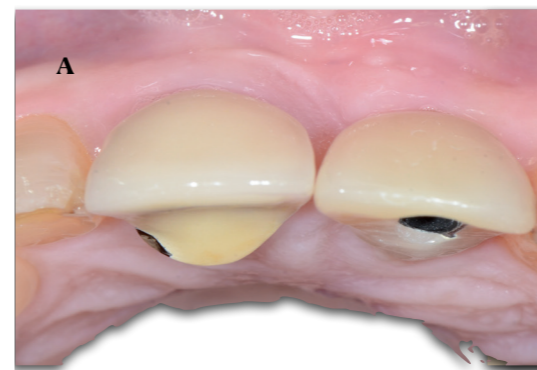
**Fig. 6 A**  
Provisional PMMA restoration

The conical connection of the OKTAGON® system, is a solution widely studied in the literature, and the long-term data, unanimously suggested by the scientific community, confirm the validity of this solution. The immediate provisional tooth was loaded with the aim to guarantee the optimal maintenance of the soft tissue architecture and maintain during all the healing time. (fig. 6)

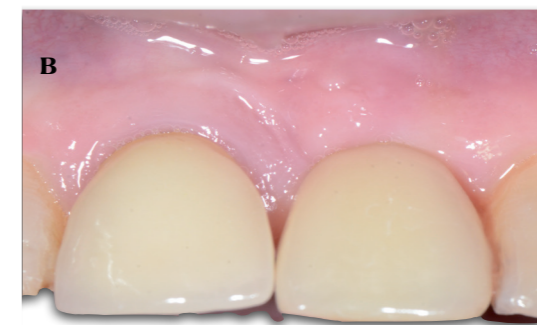
**Fig. 6 B**  
Front view provisional PMMA restoration

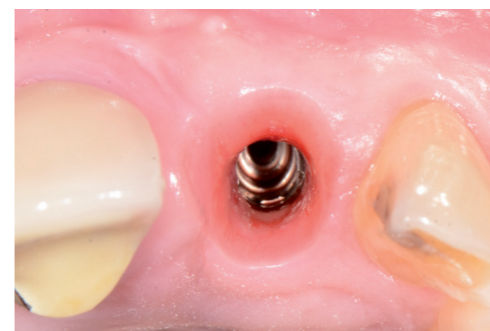
**Fig. 7**  
Tissue compliance after provisional removal (6 months after surgery)

The use of sticky bone and L-PRF in immediate implant sites helps to prevent hard and soft-tissue collapse and may favor faster and sounder healing. After 6 months (fig. 7), the implant was connected to a Ti-Base and screw retained zirconia crown as final restoration. The facial and interdental soft tissue was maintained with appreciable success after 2 years.

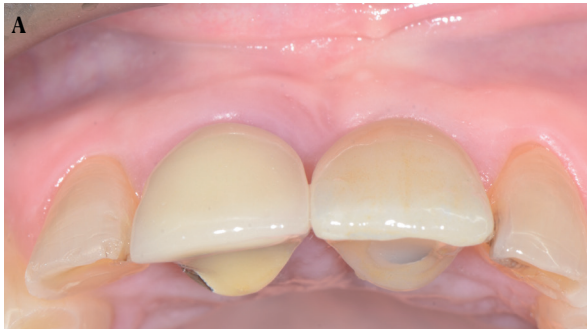
**Fig. 8 A**

Definitive zirconia restoration

CBCT control at 6 months

The pre-treatment and 2-year post-treatment computed tomography scans revealed marginal bone preservation (fig. 8)

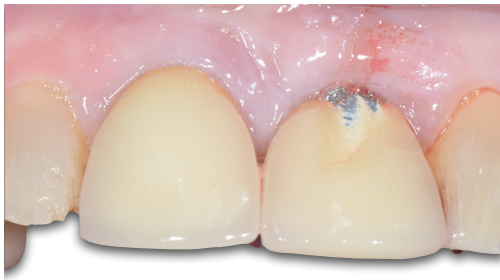
**Fig. 9 A**

Clinical situation at T0

An OKTAGON® BONE LEVEL TAPERED RC (Regular Connect) implant was inserted at the time of the extraction and later restored with a screw retained zirconia crown. (fig. 9)

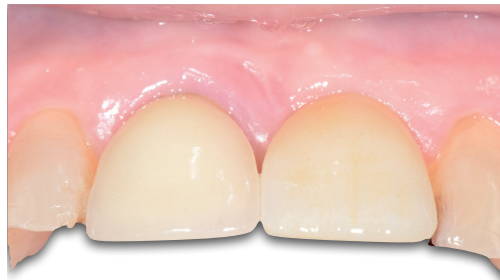
**Fig. 9 B**

Clinical situation at 12 months
